Test Report no. ID942

Burst pressure test of TST Hose Protection/Shroud

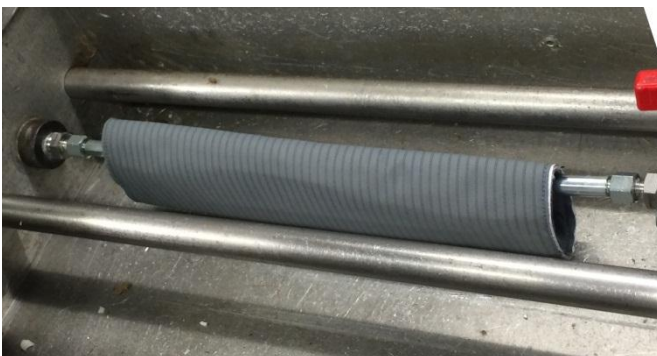
Picture 1: installed High Pressure Hose with Test sample

Minimum burst pressure of high hose:	1800 bar
Test fluid:	maxifluid 15k
Medium temperature:	approx. 20°C
Ambient Temperature:	approx. 20°C
Typ of installation:	straight Position
Free hose length:	400mm
Test sample length:	approx.. 400mm

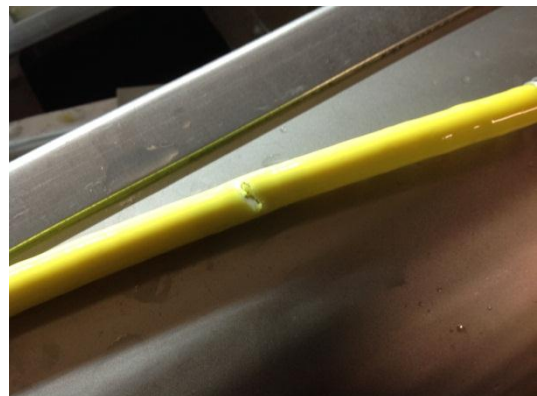
Picture 2: Burst of High Pressure Hose

Description	Burst Pressure	Test result
Hose Protection (part no. 5660045)	2142 bar	No damage on Hose Protection after hose burst
